## The Importance of X-Rays in the Standing Position

By Dr. Tim Maggs

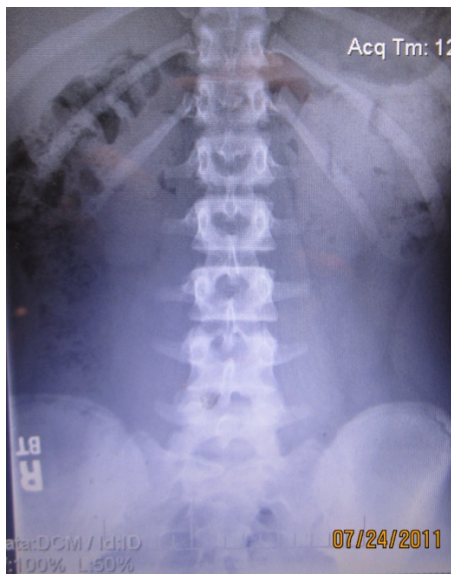
Fig. 1

In November, 2010, the patient went to her orthopedist who ordered x-rays in the lying down position. The front to back view (Fig. 1) and the side view (Fig. 2) are seen here. Upon viewing the x-rays, Dr. Orthopedist said they were negative (nothing wrong).

view in the standing position (Fig. 3) shows a significantly different impression than the view that was taken lying down (Fig. 1). Likewise, the side view in the standing position (Fig. 4) shows a significantly different impression than the view that was taken lying down (Fig. 2).

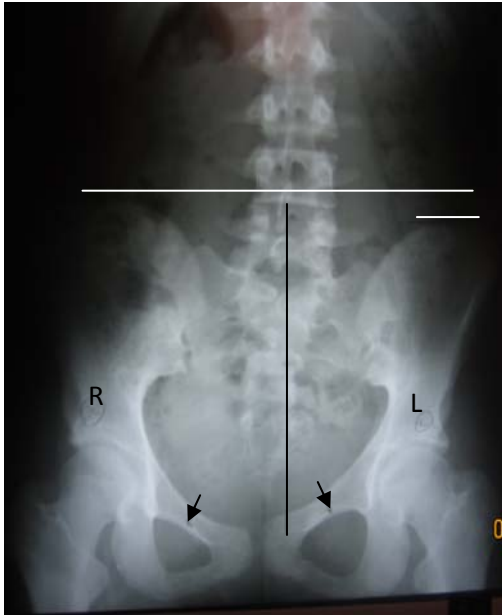
Fig. 3

In Fig. 3, the vertical line in the center represents the patient's center of gravity. We can see there is a severe misalignment between the spine and the front of the pelvis. Secondly, the horizontal lines at the top of the pelvis show an imbalance between the right and left pelvis, causing low back, hip, knee and leg length imbalances. Finally, the arrows are pointing to the obturator foramen, which actually are the same size, but appear differently due to the abnormal rotations of the pelvis.

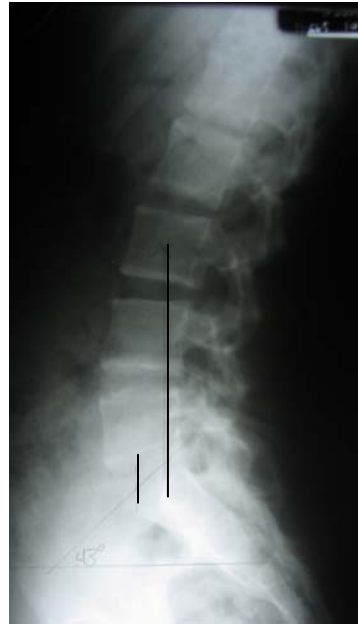
Fig. 4

In Fig. 4, the long vertical line represents the center of gravity from the side. It's supposed to be going through the short vertical line, but this patient's weight bearing is in the back of the spine, with abnormal weight going through the back of the discs and the nerve roots (predictably causing disc bulges).
